# Goulden Thurston Wetland Restoration Project

(COL-F19- W-2787)

Prepared for: Fish and Wildlife Compensation Program

Prepared by: Gregoire Lamoureux

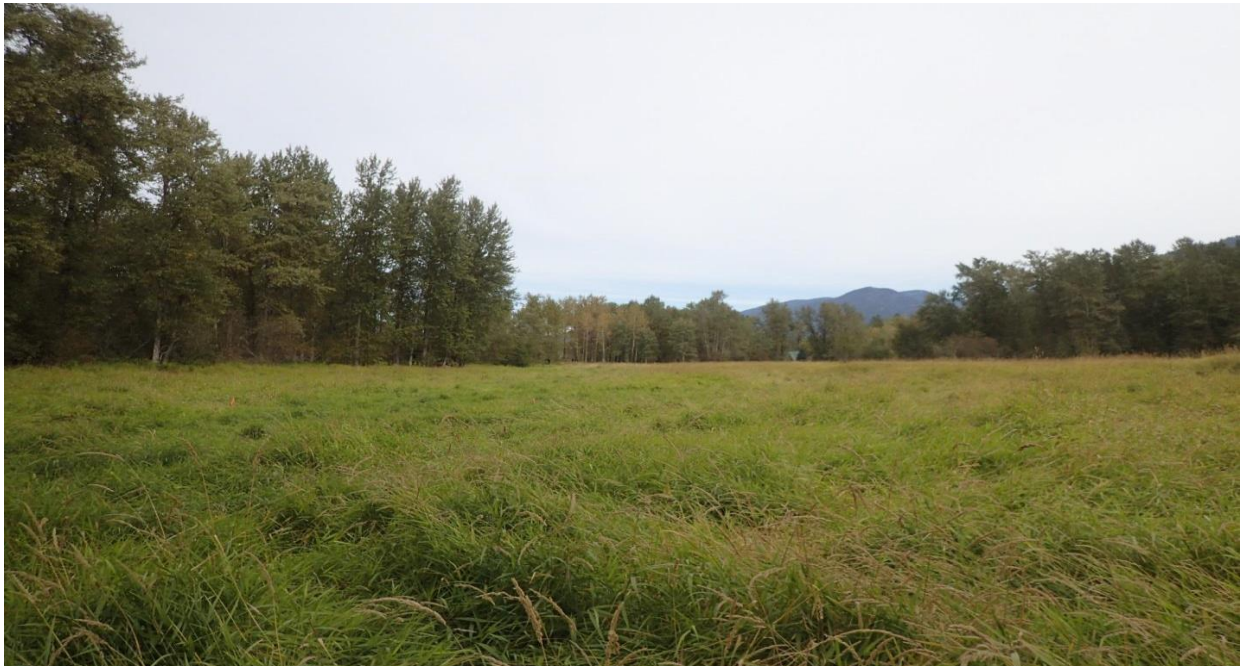
Figure 1. The wetland area before the restoration project, June 2018.

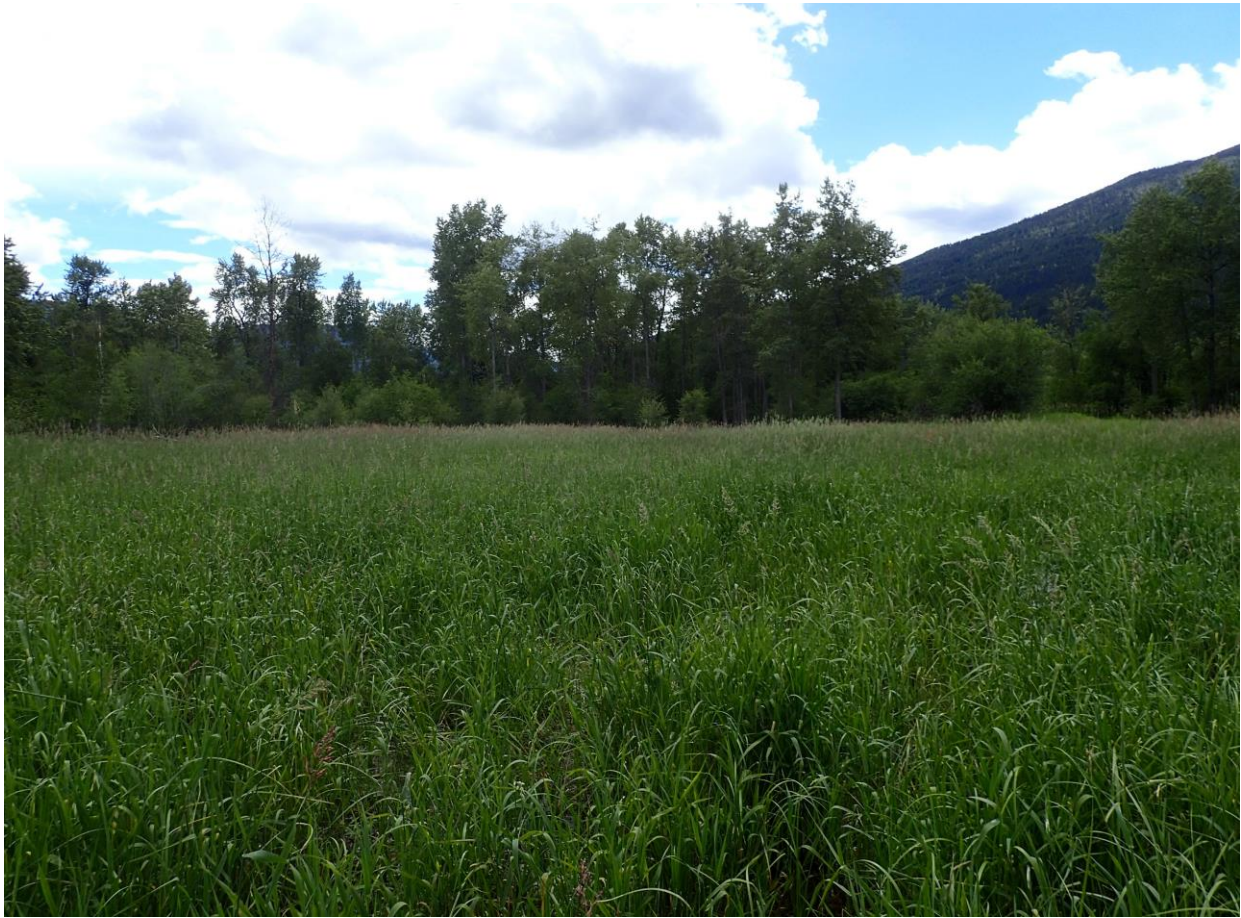
Figure 2. The wetland area before the restoration project, July 2018.

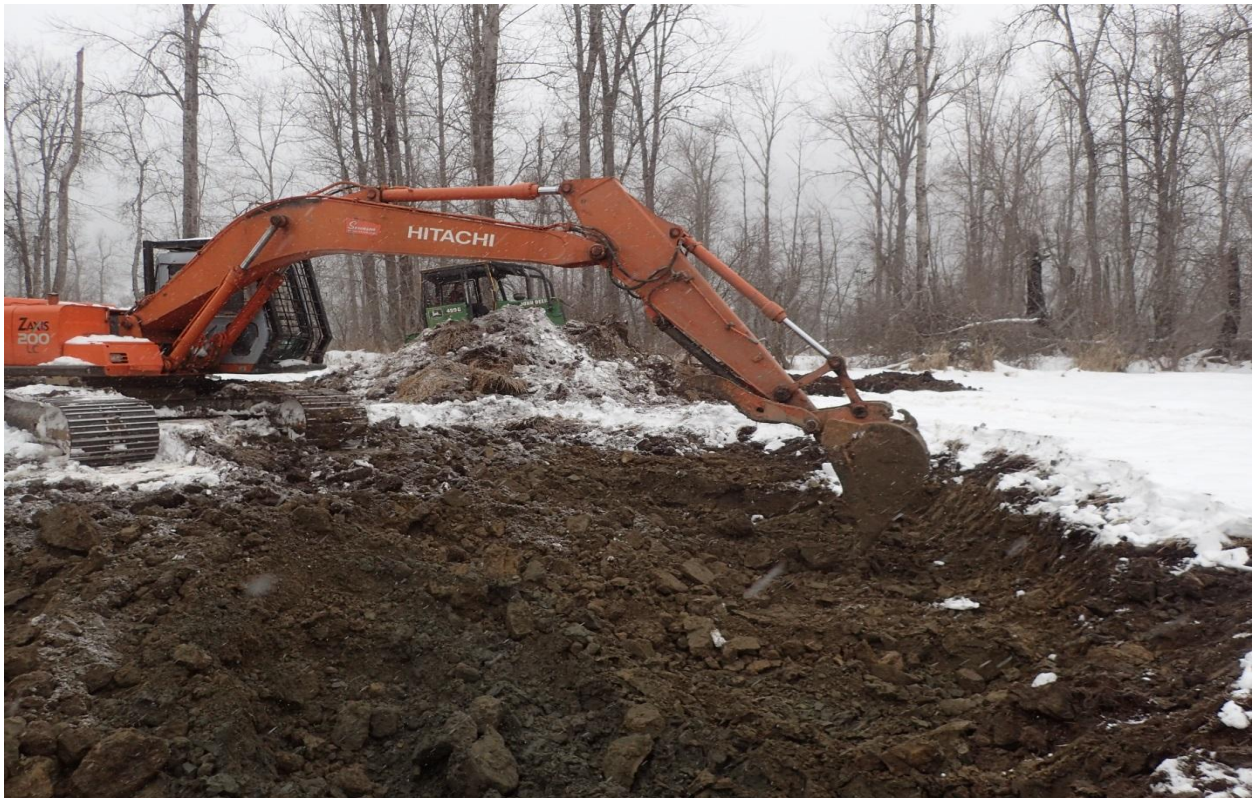
Figure 6. Excavating the first wetland, January 2019.

Three shallow wetlands were excavated in the southern part of the field. The excavation work was completed in January to minimize the impact on wildlife that inhabited the area and was done at a very gentle slope to minimize erosion. An elevated area between and around the wetlands was maintained in order to help prevent the spread of diseases and invasive species.

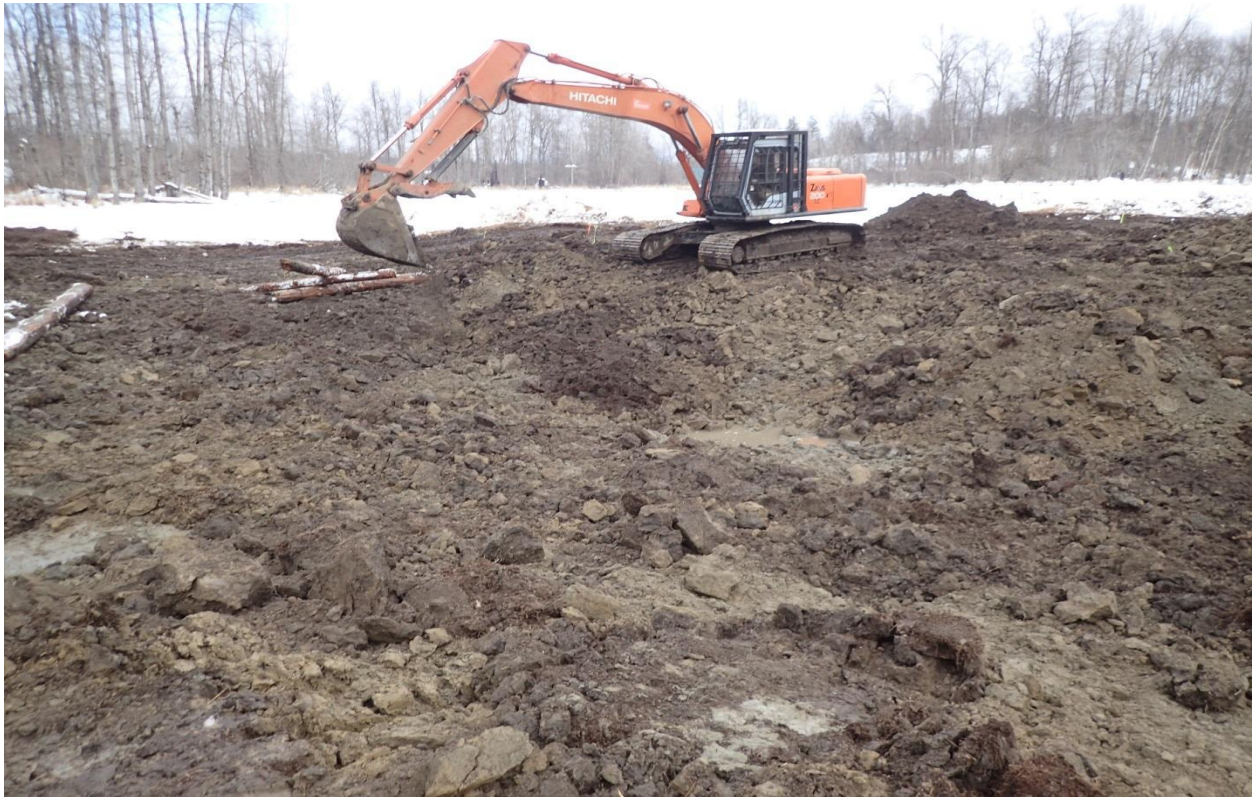
Figure 7. Excavating the second wetland, January 2019.

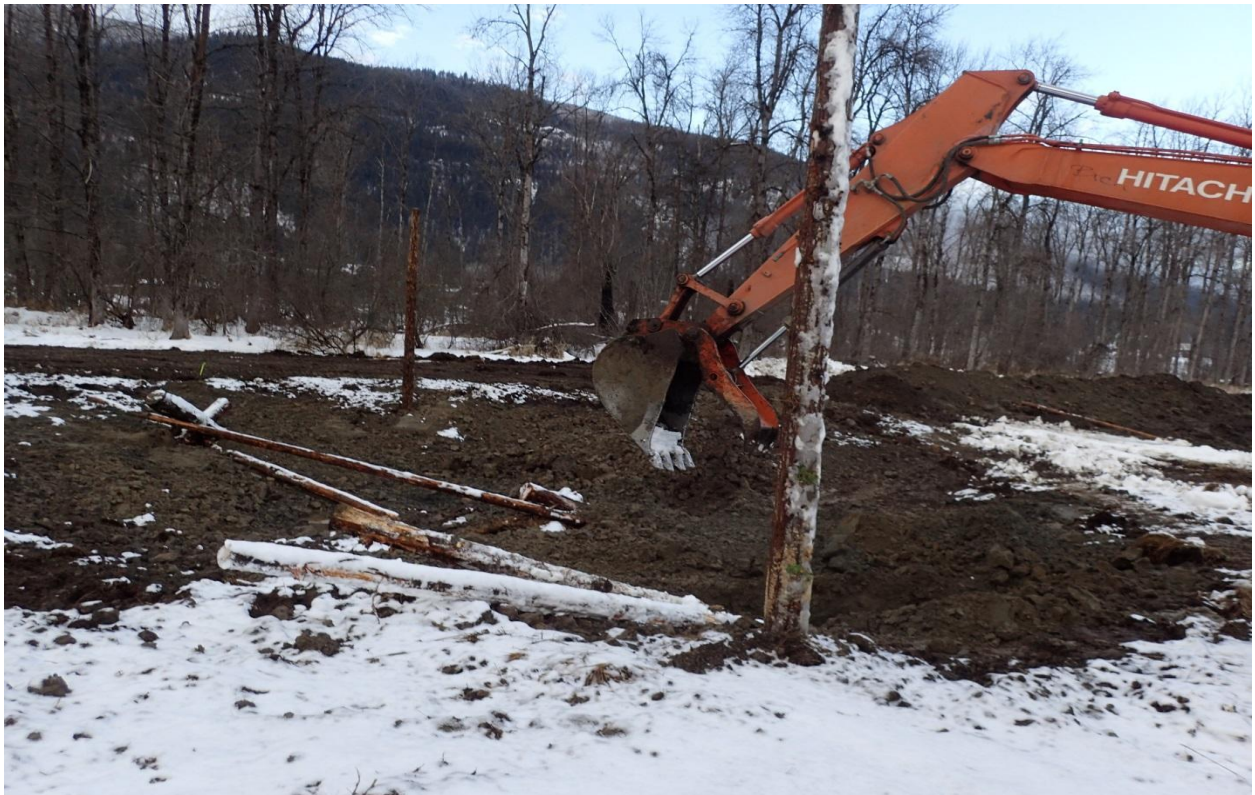
Figure 8. Planting posts for bird and bat houses, January 2019.

Nesting boxes and bat houses were also installed along the shoreline on cedar logs to provide long term habitat for bats and swallows. Two turtle nesting sites of approximately 32 square metres were created with sand excavated from the wetland.

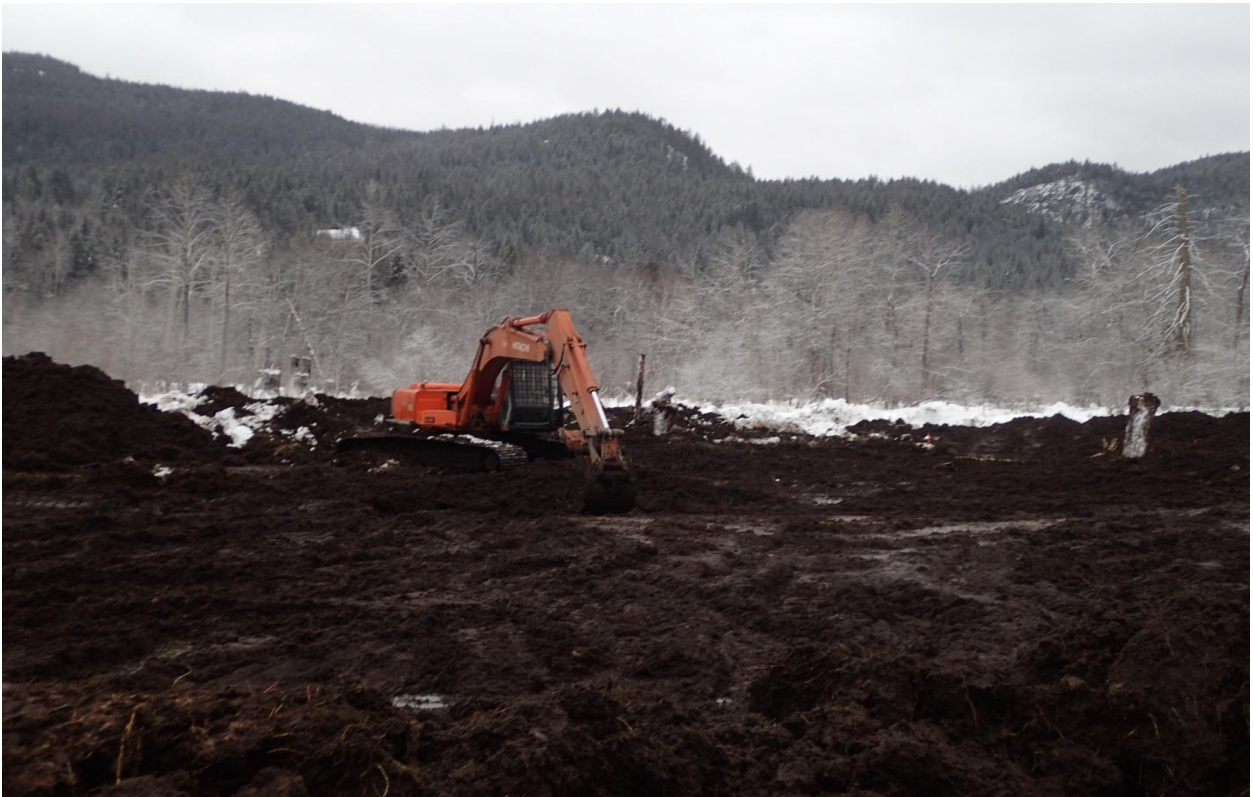
Figure 9. Excavating the third wetland, January 2019.

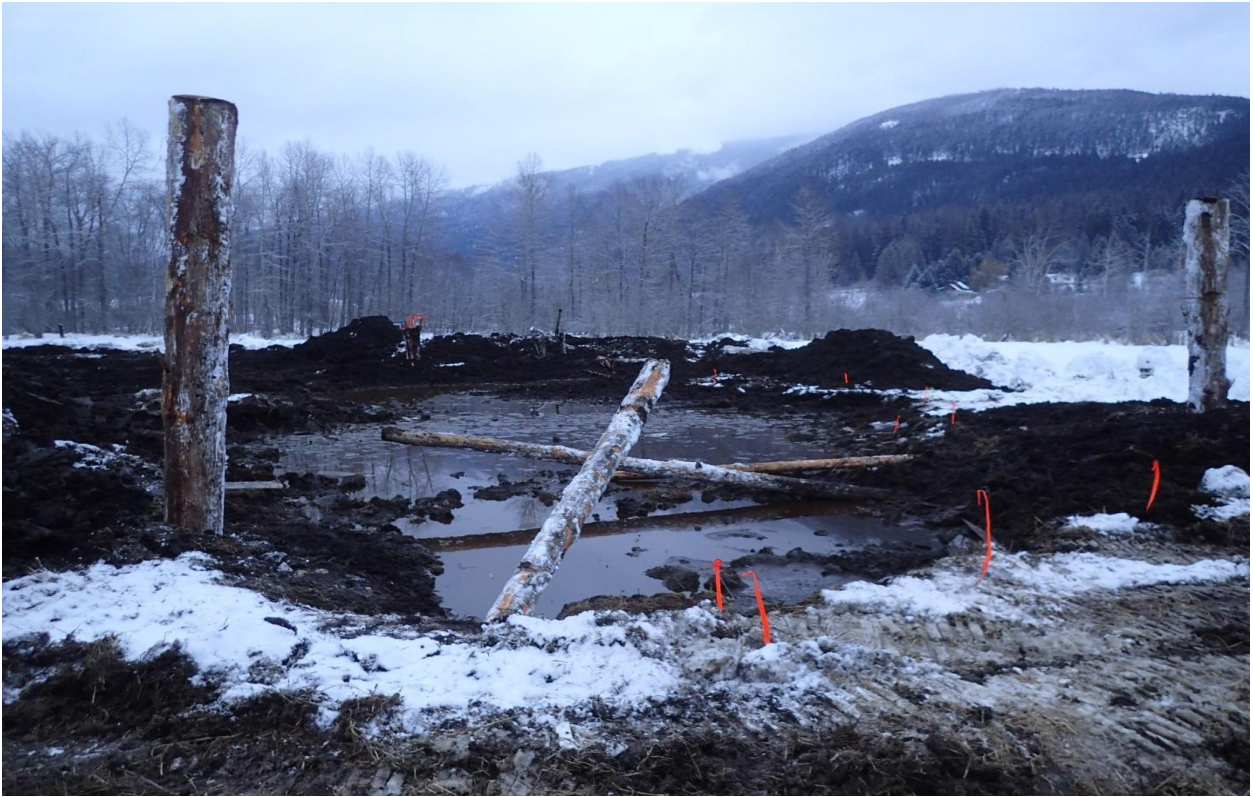
Figure 10. Posts and basking logs installed in the third wetland, January 2019.

Large logs were placed in the wetlands to create habitat for a diversity of species including amphibians, reptiles and invertebrates. Logs were also planted upright along the shoreline to mimic snags for use by woodpeckers and other cavity nesting birds until eventually they rot away and provide food for insects.

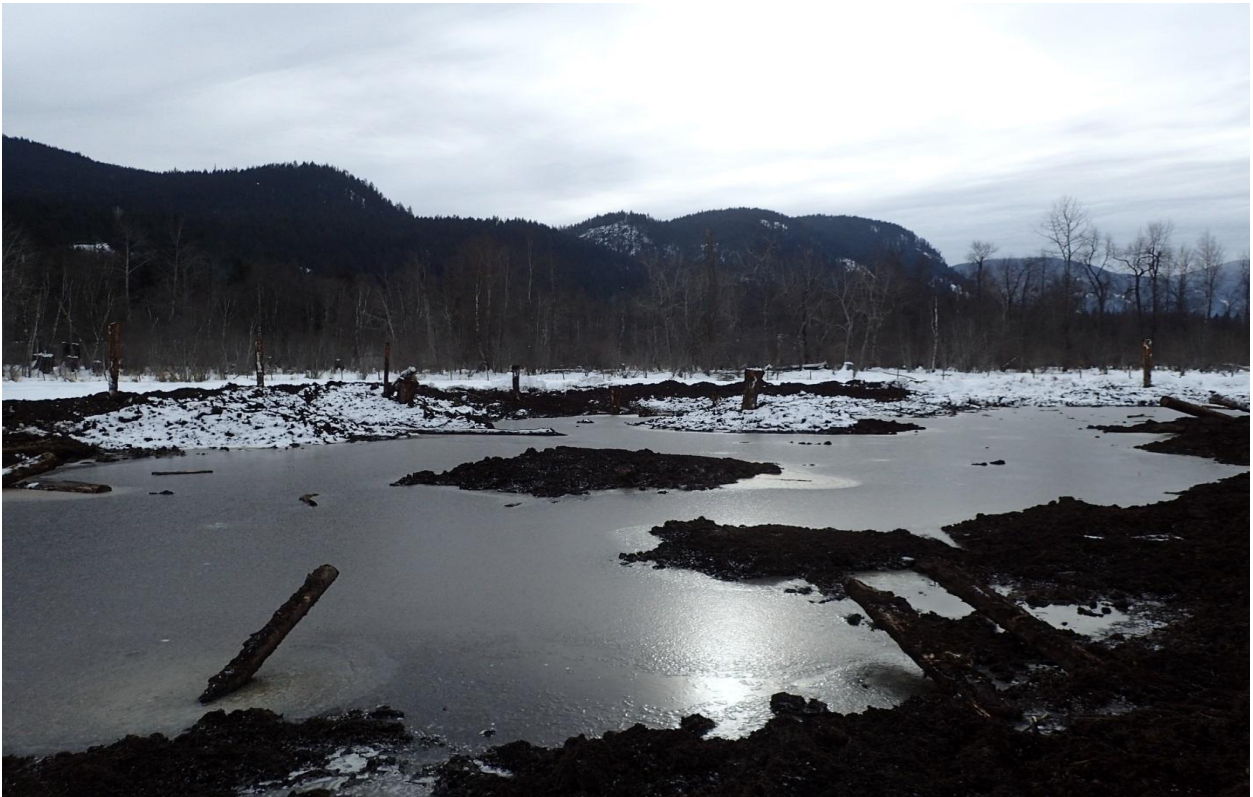
Figure 11. Wetland excavation completed, January 31, 2019.

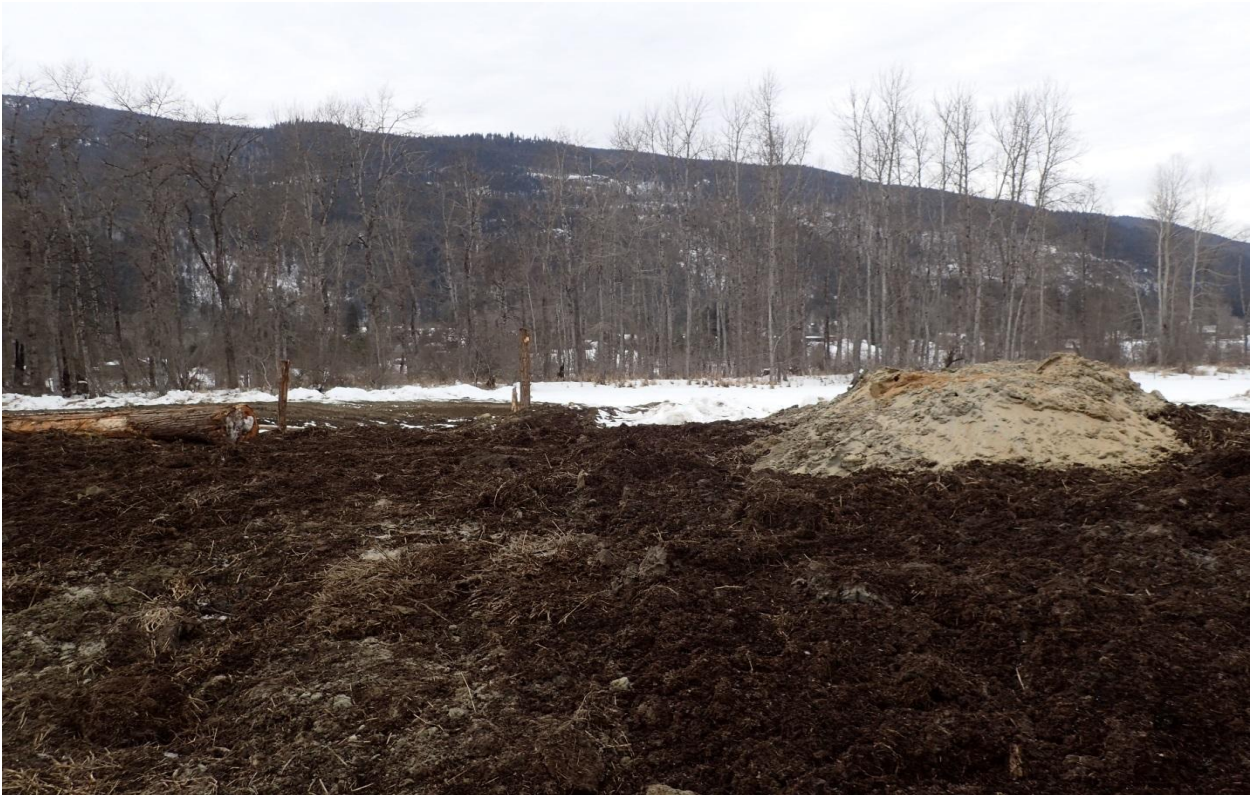
Figure 12. Nesting site for turtles, January 2019.

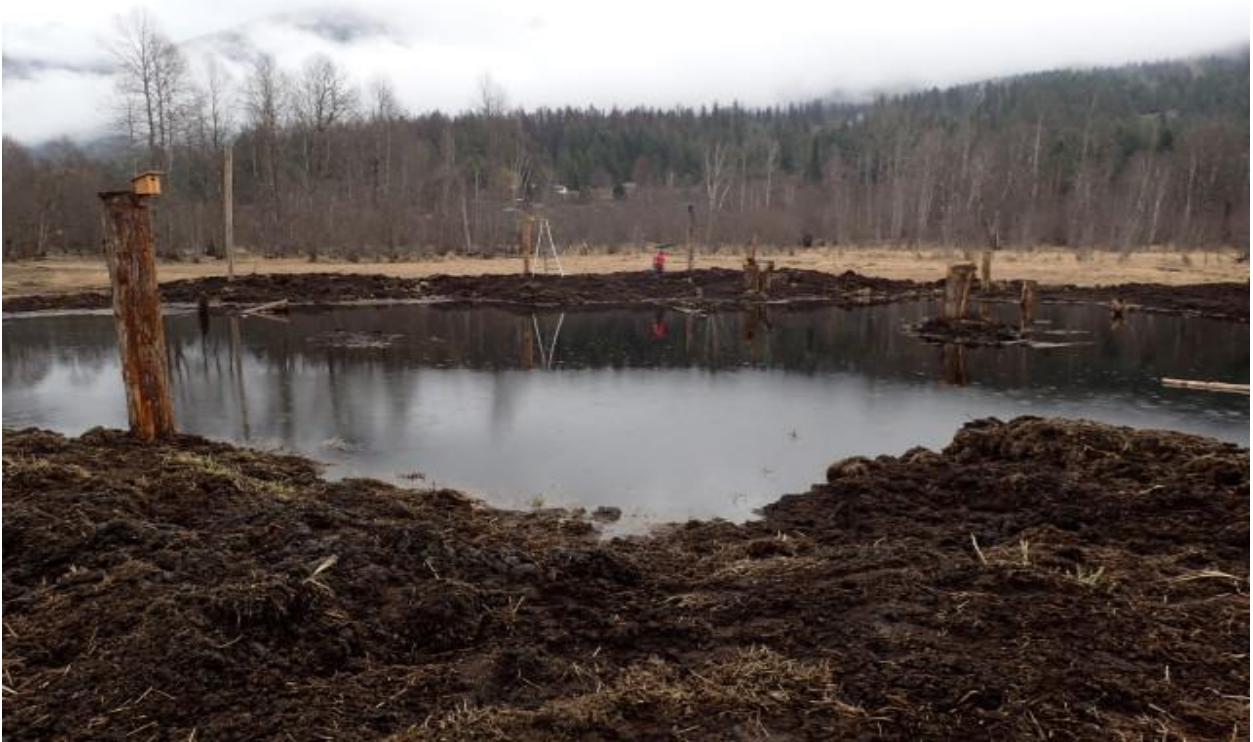
Figure 13. Installing bird nesting boxes, April 5, 2019.

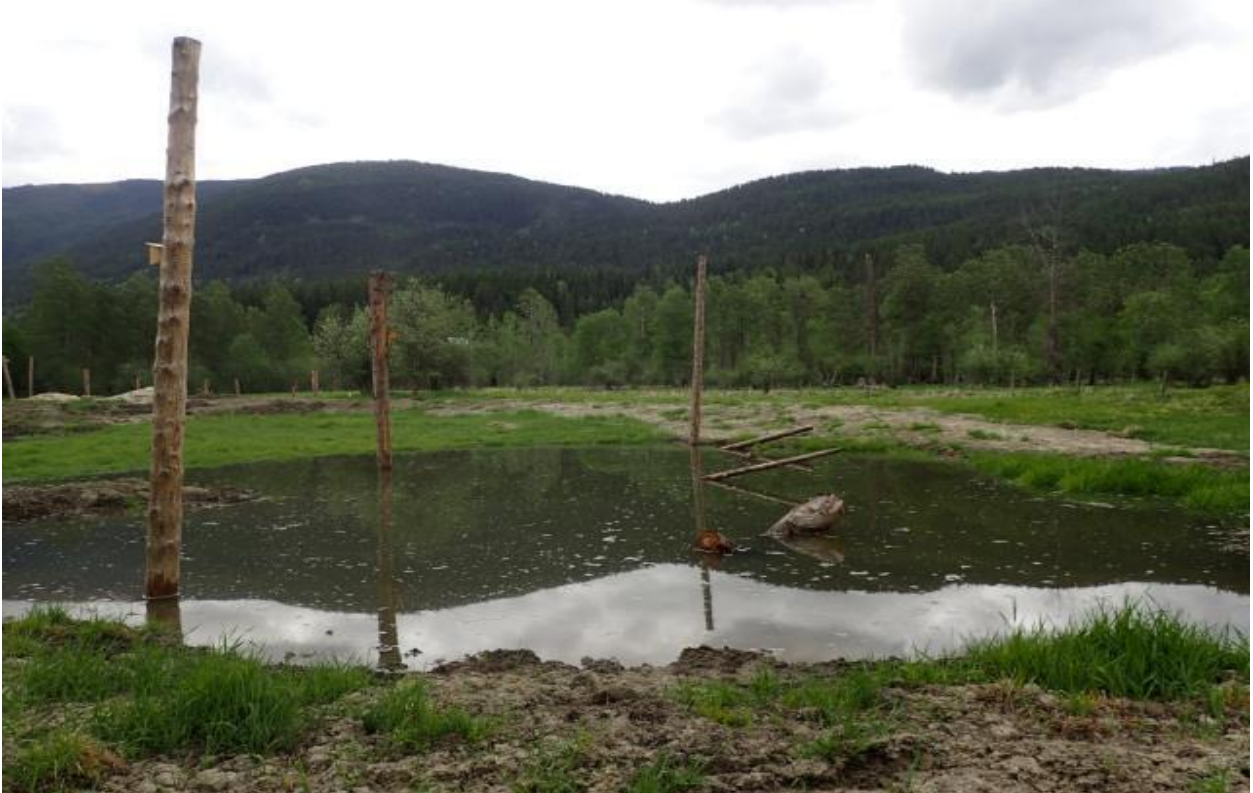
Figure 20. The ephemeral wetlands are now full, May 18, 2019.

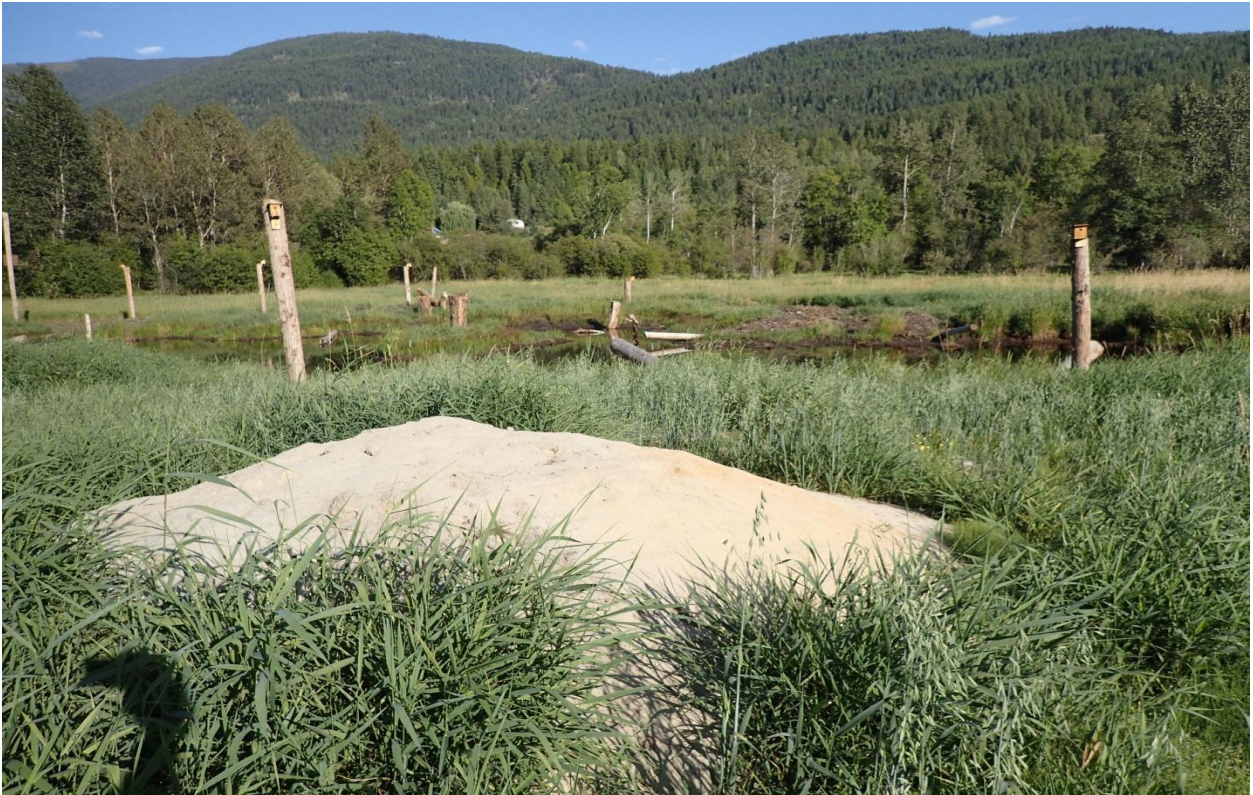
Figure 22. One of two turtle nesting sites created at the wetlands, August 2019.

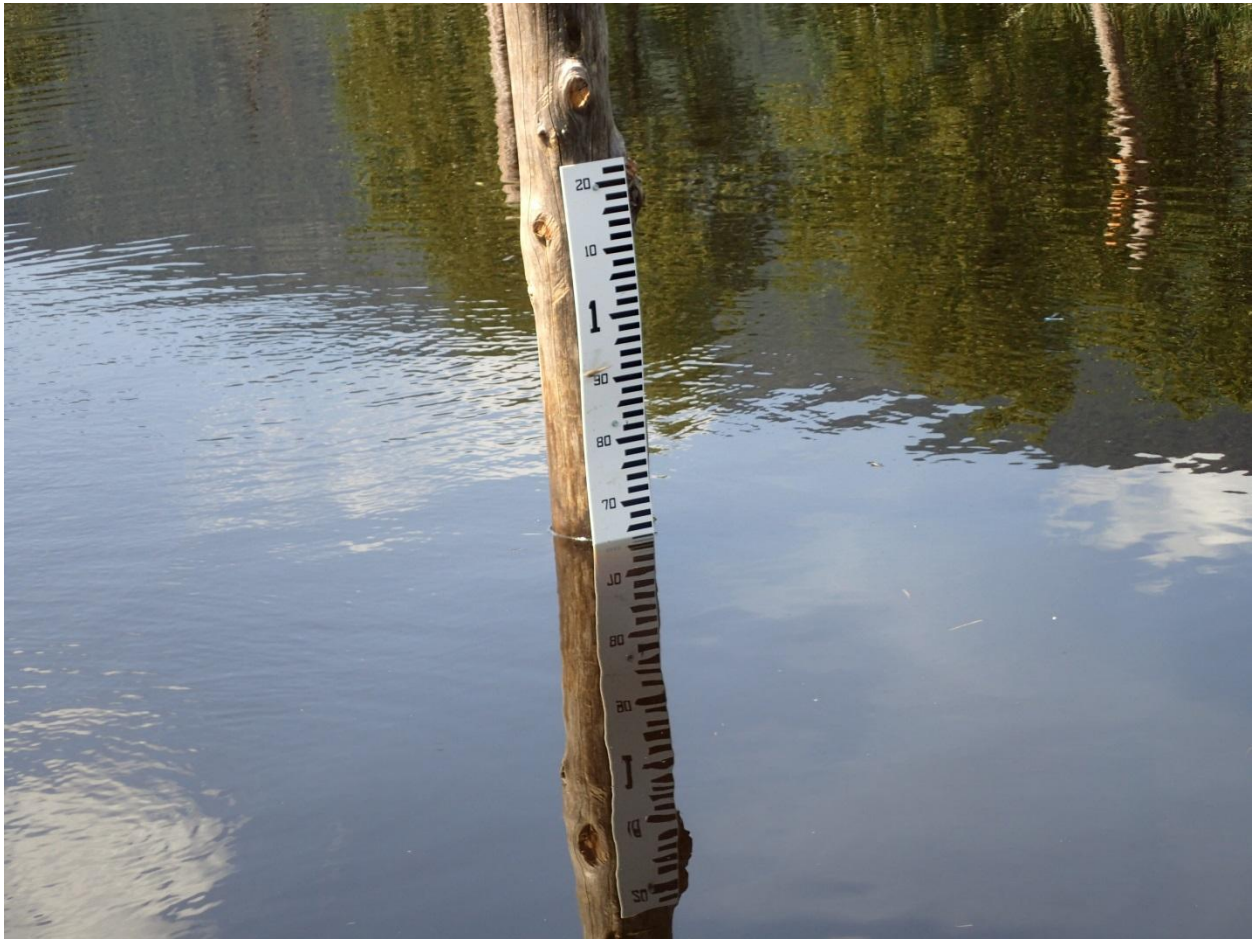
Figure 23. One of the staff gauges installed in the wetland, August 15, 2019.

as water and air temperature, pH, conductivity, water level, and wildlife observations are being monitored regularly by members of the Streamkeepers. A more detailed baseline assessment which additionally includes benthic invertebrate community, plant success, in-situ water quality, and lab samples was completed by Integrated Ecological Research in July 2019.

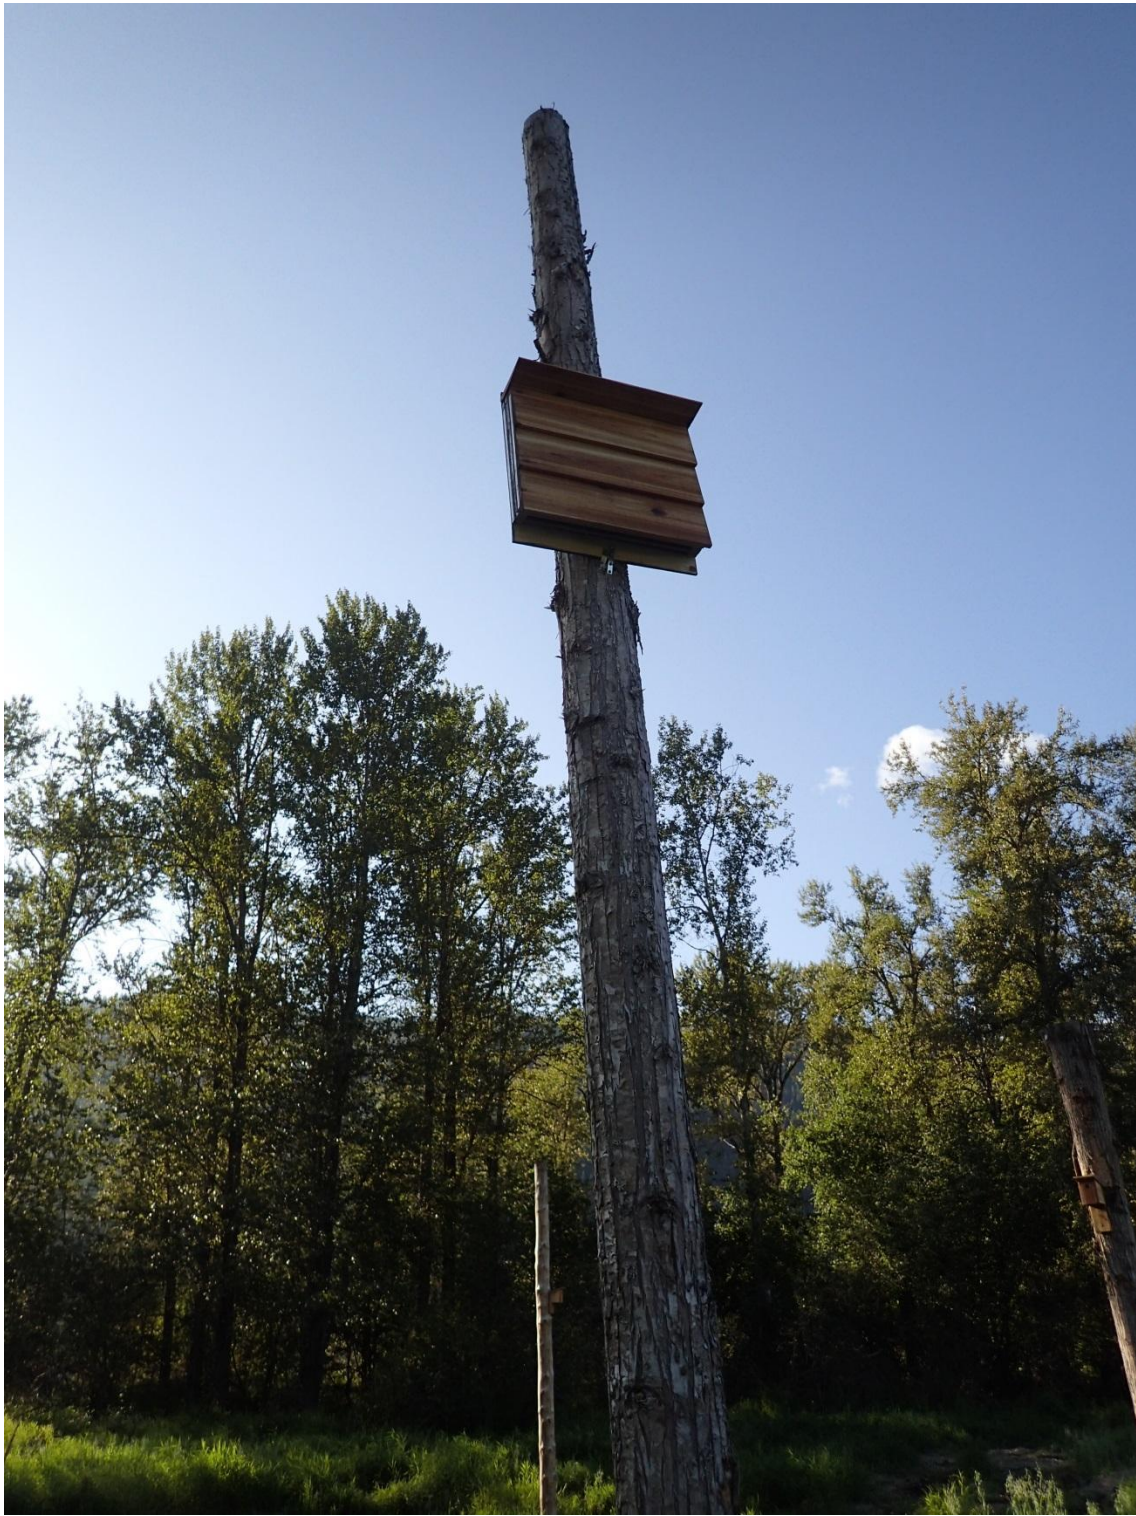
Figure 24. One of the bat houses installed at the wetlands, August 26, 2019.

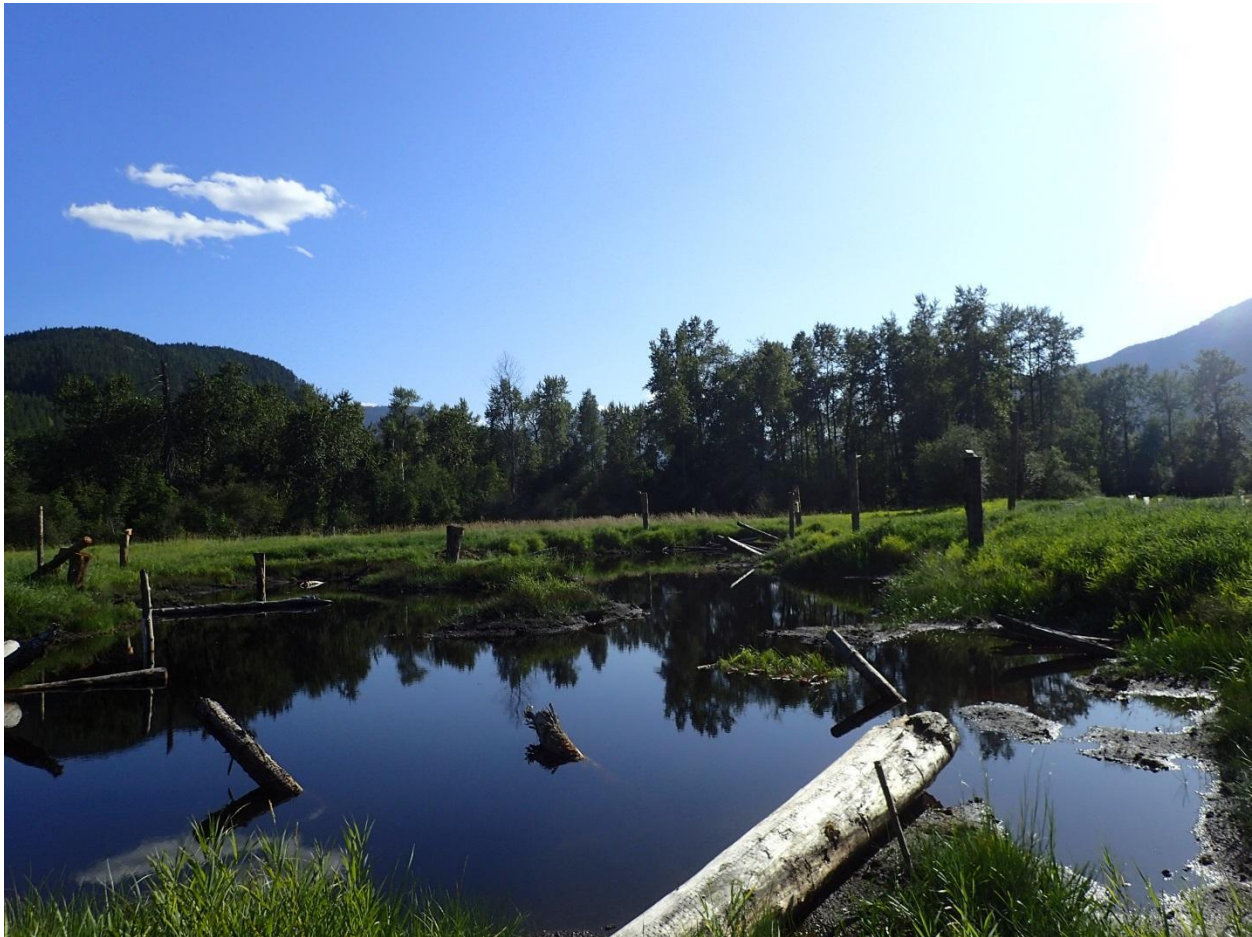
Figure 25. Wetland Restored, August 26, 2019.
