Cherry Creek Wetland Restoration Project 2016/2017 Final Report

February, 2017

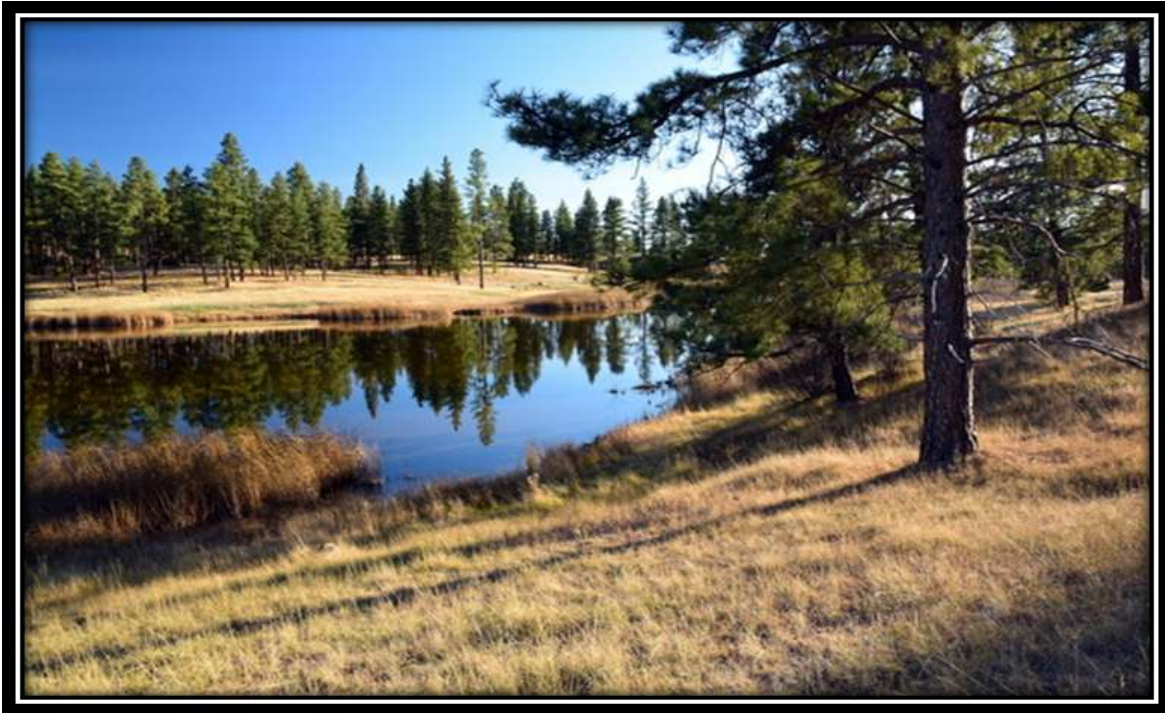
Photo 4: Typical Wetland Site Characteristics (Sites 1 and 3)

Sedges (*Carex* spp.) and reed canary grass (*Phalaris arundinacea*) were the predominant species on Wetland sites 1 and 3 (Photo 4).

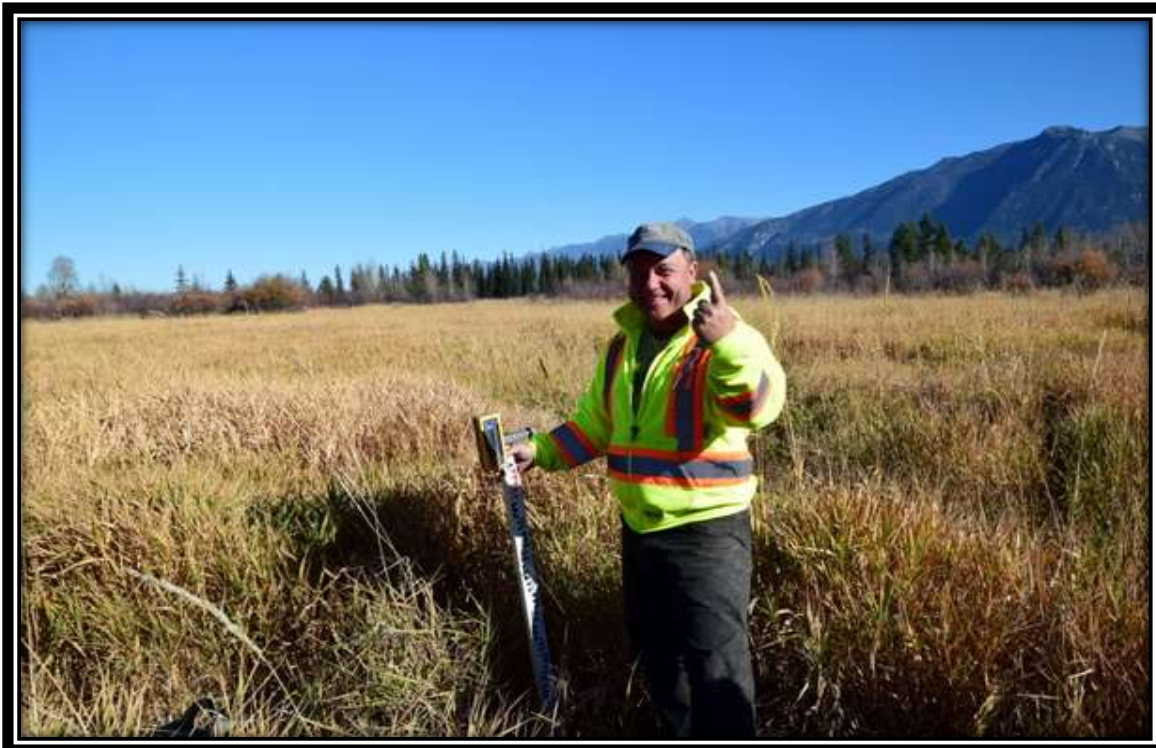
Photo 7: Wetland Site Assessment and Elevation Measurements

Suitable locations for wetland restoration sites were identified through an on-site assessment (Photo 7) and suitability was verified with the use of a variety of sampling tools. This involved the determination of the current and historic elevations of groundwater at each site by using a 48-inch long tile probe and a 48-inch long soil auger. The soil texture at each location was identified by using maps, a soil auger, and by using the ribbon test.

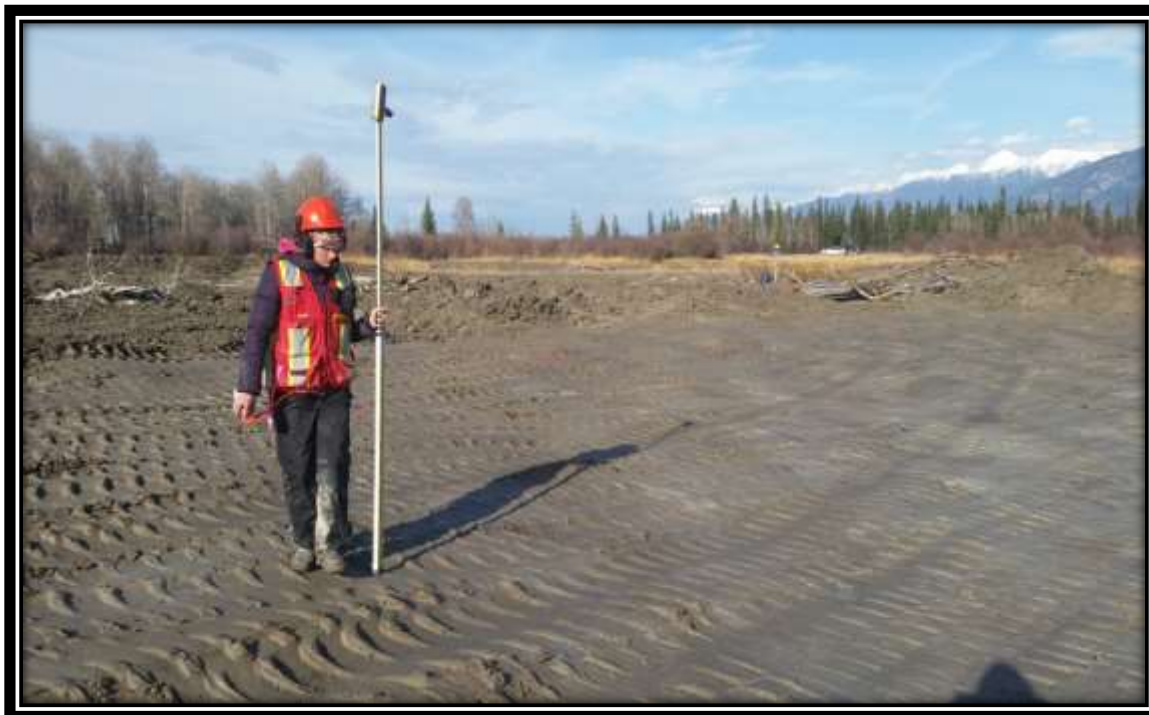
Photo 8: Wetland Site Slope Measurements

A laser level and survey rod was used to measure slope on each project site (Photo 8). The perimeter of each area was marked so that it had no more than a 6-percent slope, and changed 50cm or less from upper to lower edge.

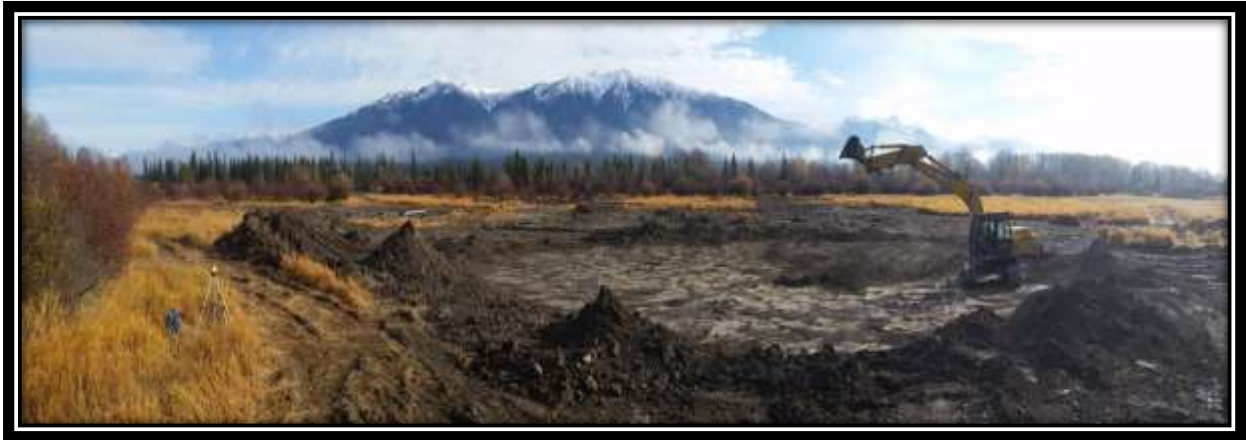
Photo 9: Shaping the Shallow Wetlands on Wetland Site 1

5. The slopes surrounding each restored wetland will generally be made gradual, averaging 5-percent or less.
6. The size and shape (Photo 9) of each wetland will take into consideration the disposition of soil (Photo 10) that would be removed to build the wetland. The excess soil will be placed in naturally appearing ridges and mounds (Photo 11) around the wetlands being restored. This soil would provide sites for planting wildflowers, trees and shrubs. Some of the soil will be placed so that it would become saturated and form wet-meadow wetlands. This soil will not be compacted and it is anticipated that the hydrology of the wet-meadows will be maintained by water flowing from the restored wetlands.

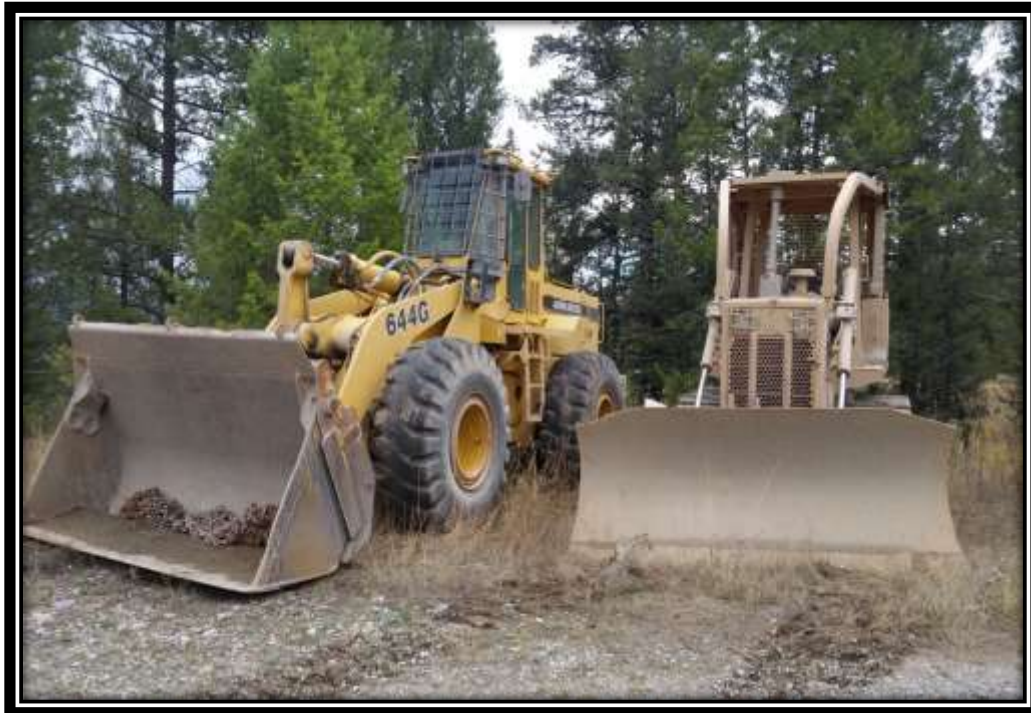
Photo 12: Wetland Restoration Equipment

Construction of the shallow water wetlands within wetland 1 and 3 was completed through a contract with Custom Dozing Ltd. Equipment used on the wetland restoration project included a D6N crawler tractor (Photo 12), a JD 200CLC excavator (Photo 13) and a 644 loader (Photo 12).

10. Heavy equipment (Photos 12 and 13) will be used to remove non-native vegetation, topsoil, and organics from each work site as well as used to dig shallow depressions for each wetland.

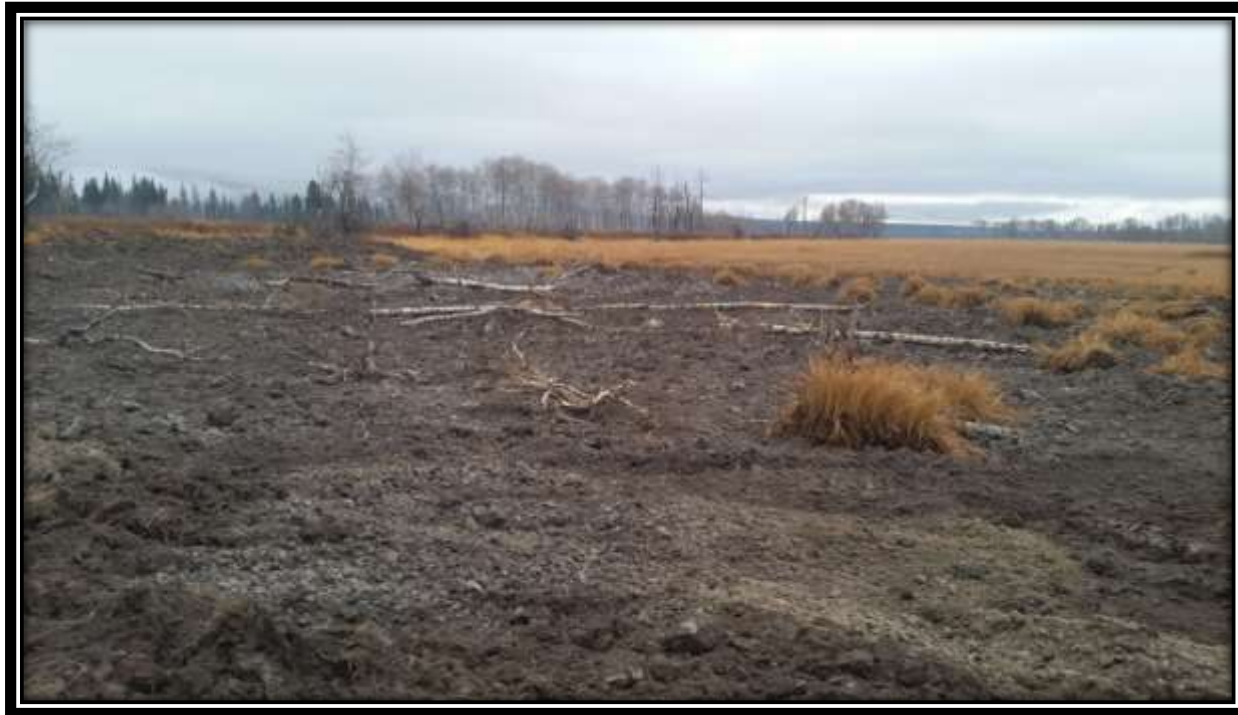
Photo 14: Woody Debris placed in the Shallow Wetlands

13. Large and small woody debris (Photo14) will be added to the wetlands to improve habitat for plants and animals.
